Report on the investigation of
of the fatal crush accident
on the general cargo vessel

Karina C

at Seville, Spain

on 24 May 2019

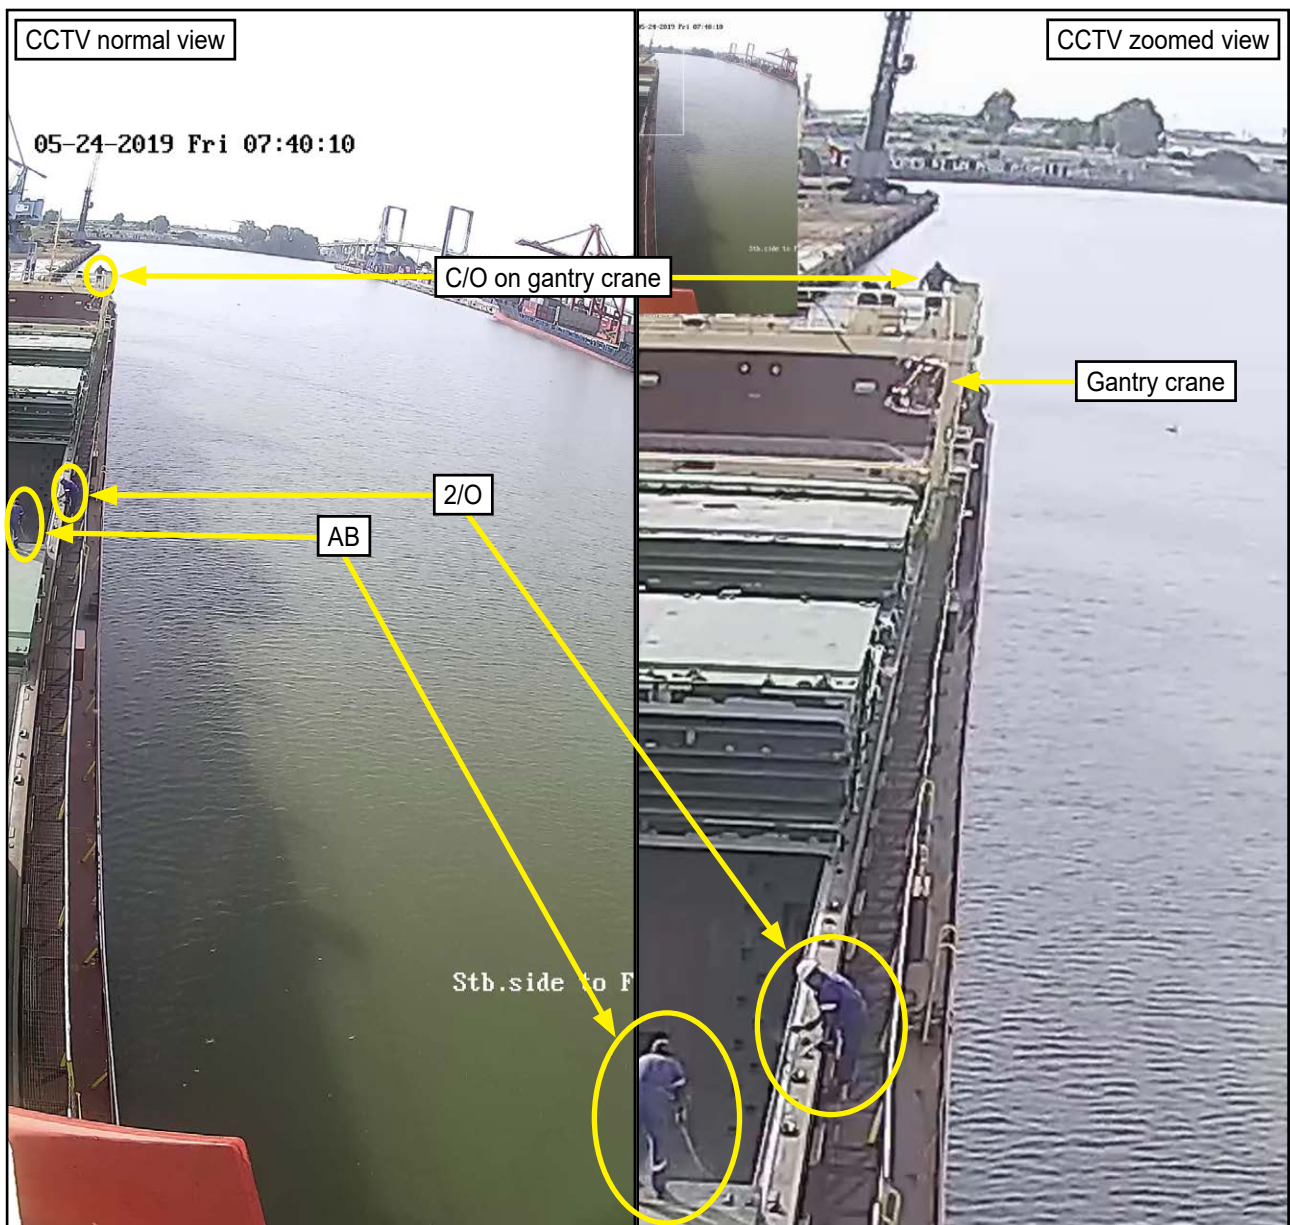
Figure 1: Crew working on deck

During the task of clearing the cement residue from the hatch covers and coamings, one AB was observed walking along and leaning over the unprotected edge of a hatch cover (**Figure 1**). Working close to unprotected open hatch covers is a well-recognised hazard and the consequence of a simple slip or trip, or even a medical event, can often have fatal consequences. The UK Working at Height Regulations require personnel working in such areas to be protected, either by the rigging of temporary guardrails, or by the wearing of a safety harness and the rigging of a fall prevention system (**Figure 18**). This requirement was repeated in Carisbrooke's SMS manual, but on the day of the accident, portable guardrails were not rigged and safety harnesses and fall prevention lanyards were not used.

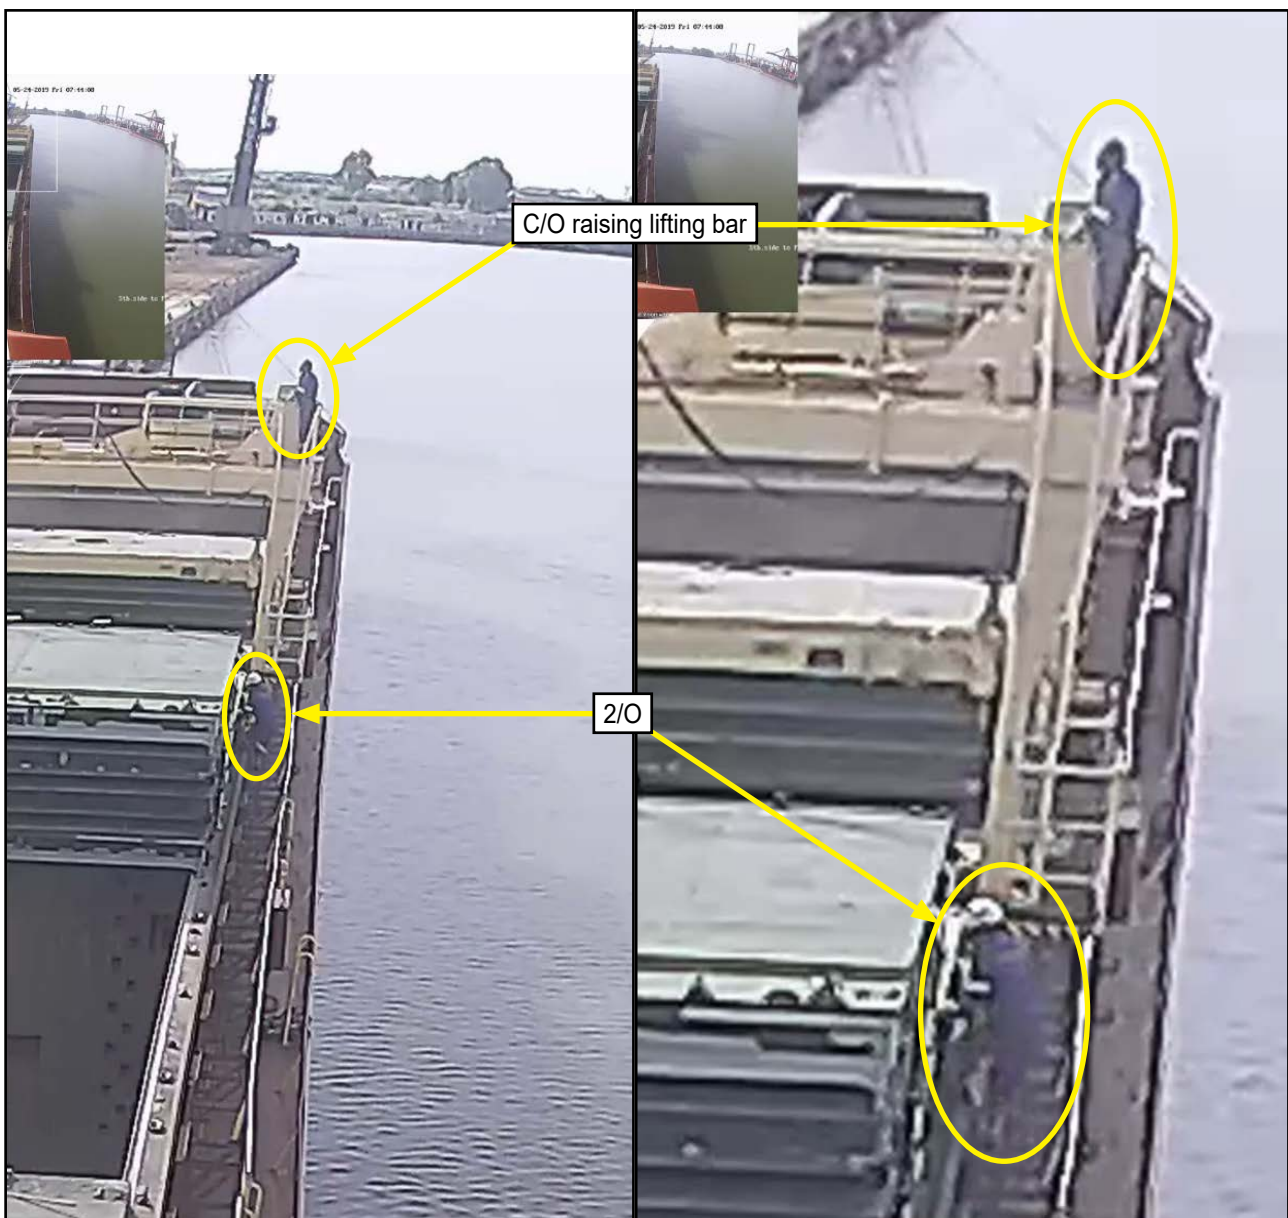
Figure 4: Zoomed CCTV screenshot showing the second officer climbing onto cargo hold hatch coaming at 0944:10

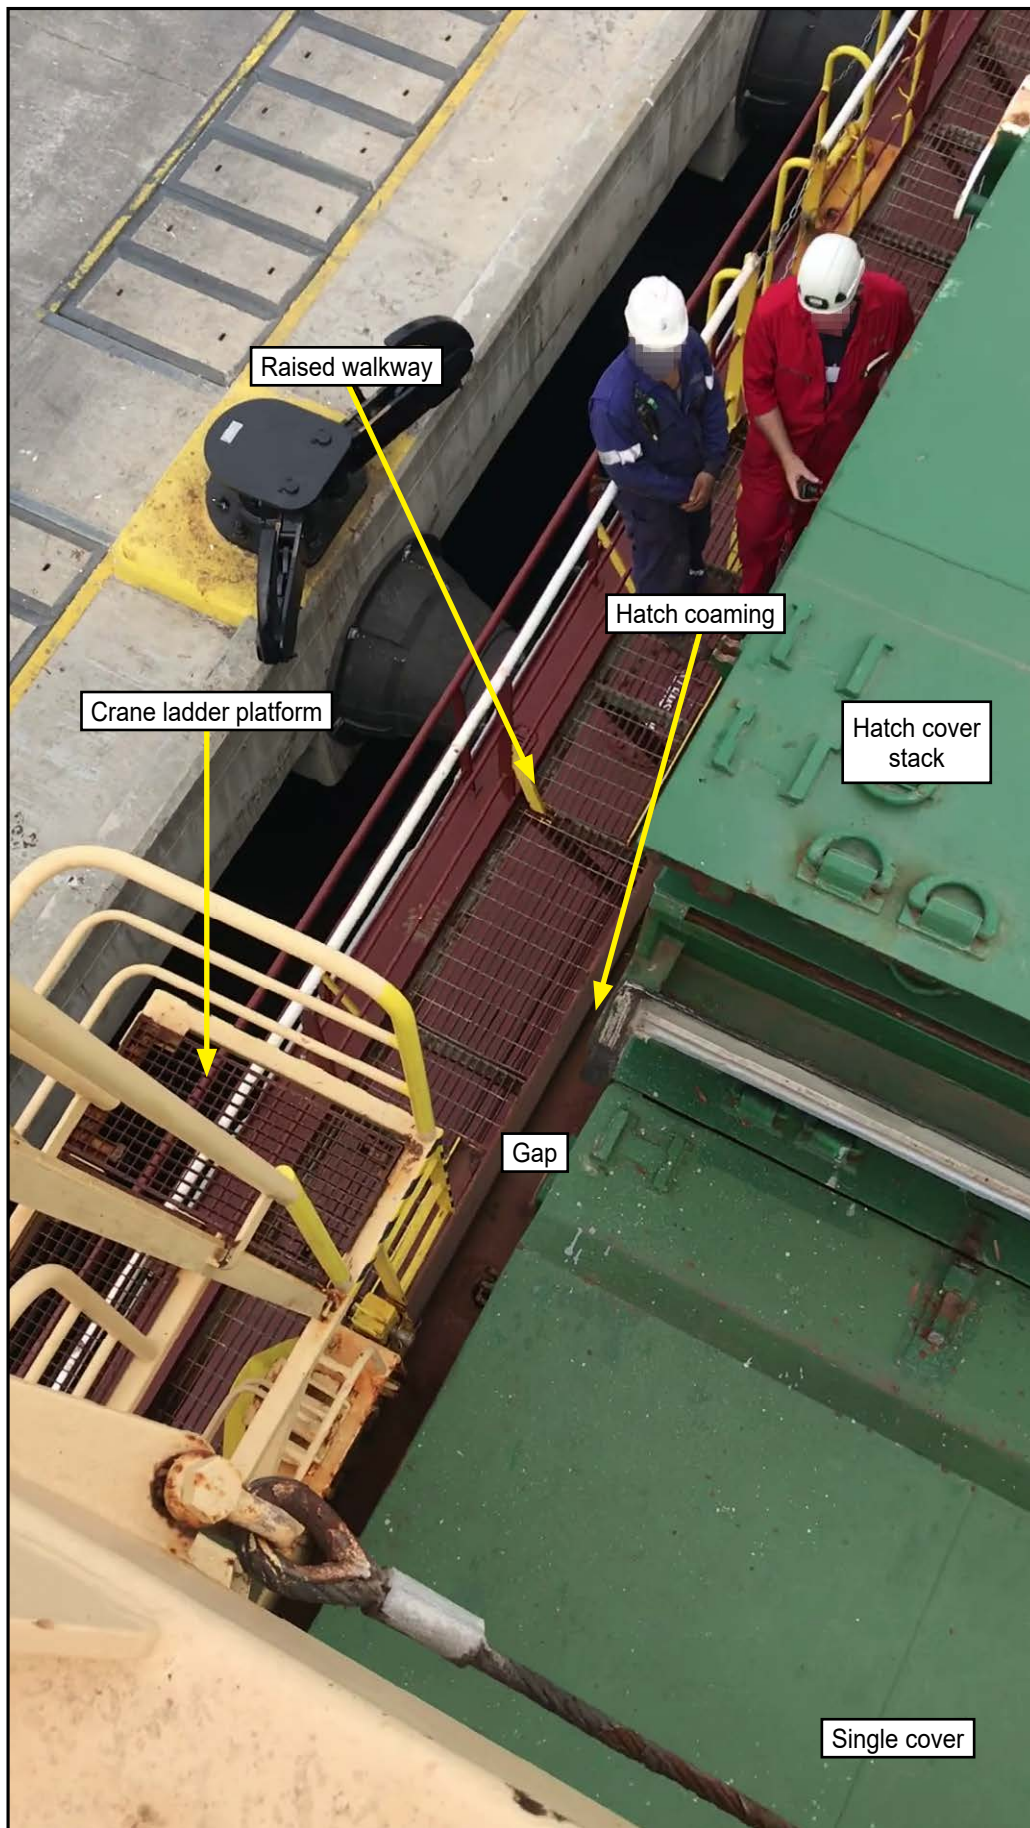
Figure 5: Reconstruction showing the distance between the crane ladder platform and the stack of hatch covers when the second officer climbed onto the coaming

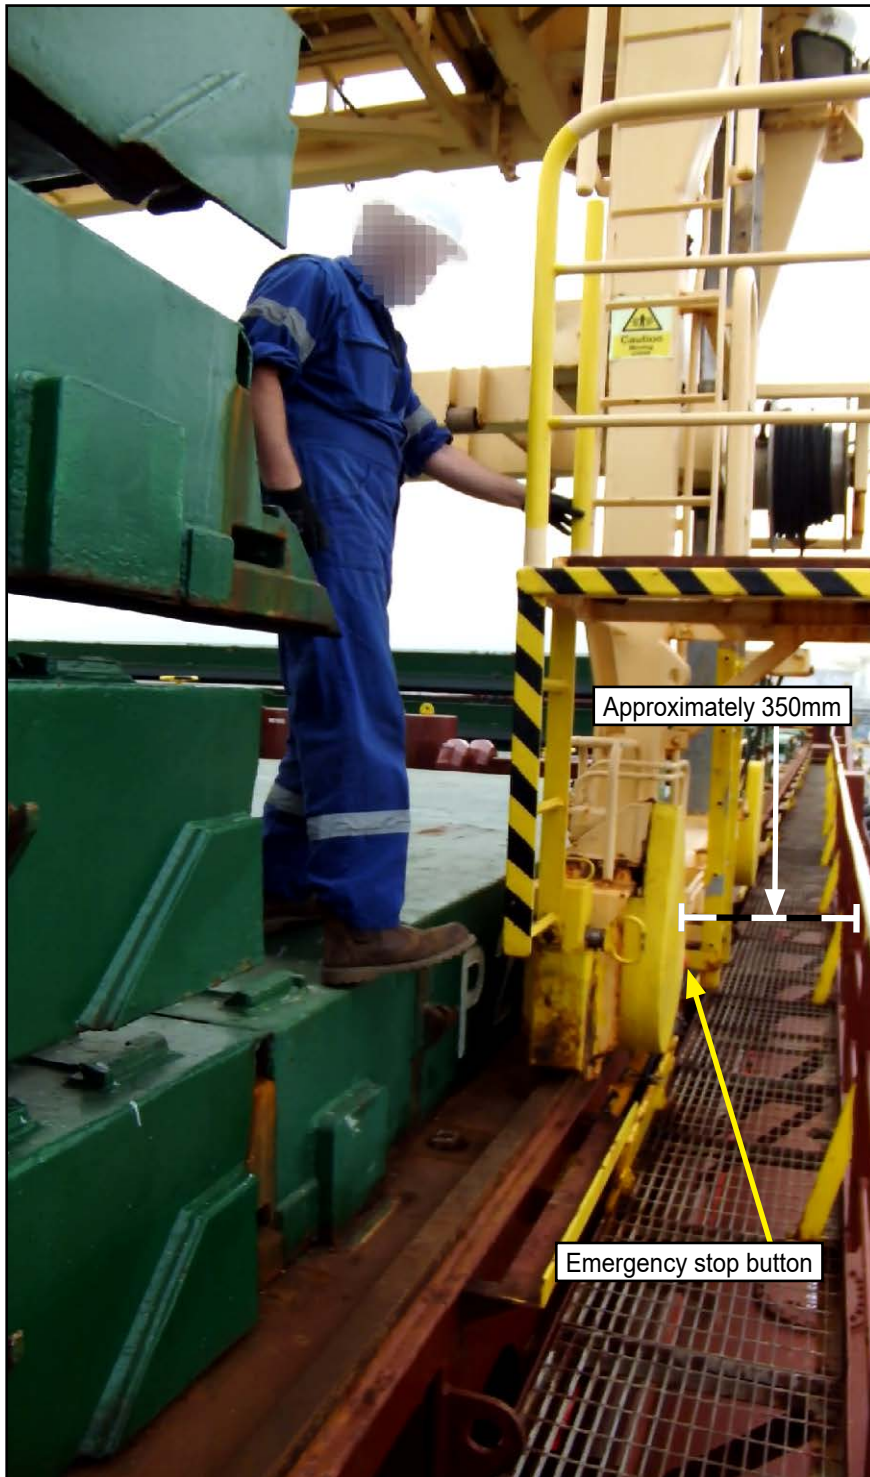
Figure 12: Access to starboard emergency stop

- It was impossible for the 2/O to reach the gantry crane emergency stop button (**Figure 12**) from the position in which he became trapped.
- The gantry crane's audible warning bell could be clearly heard at walkway level.

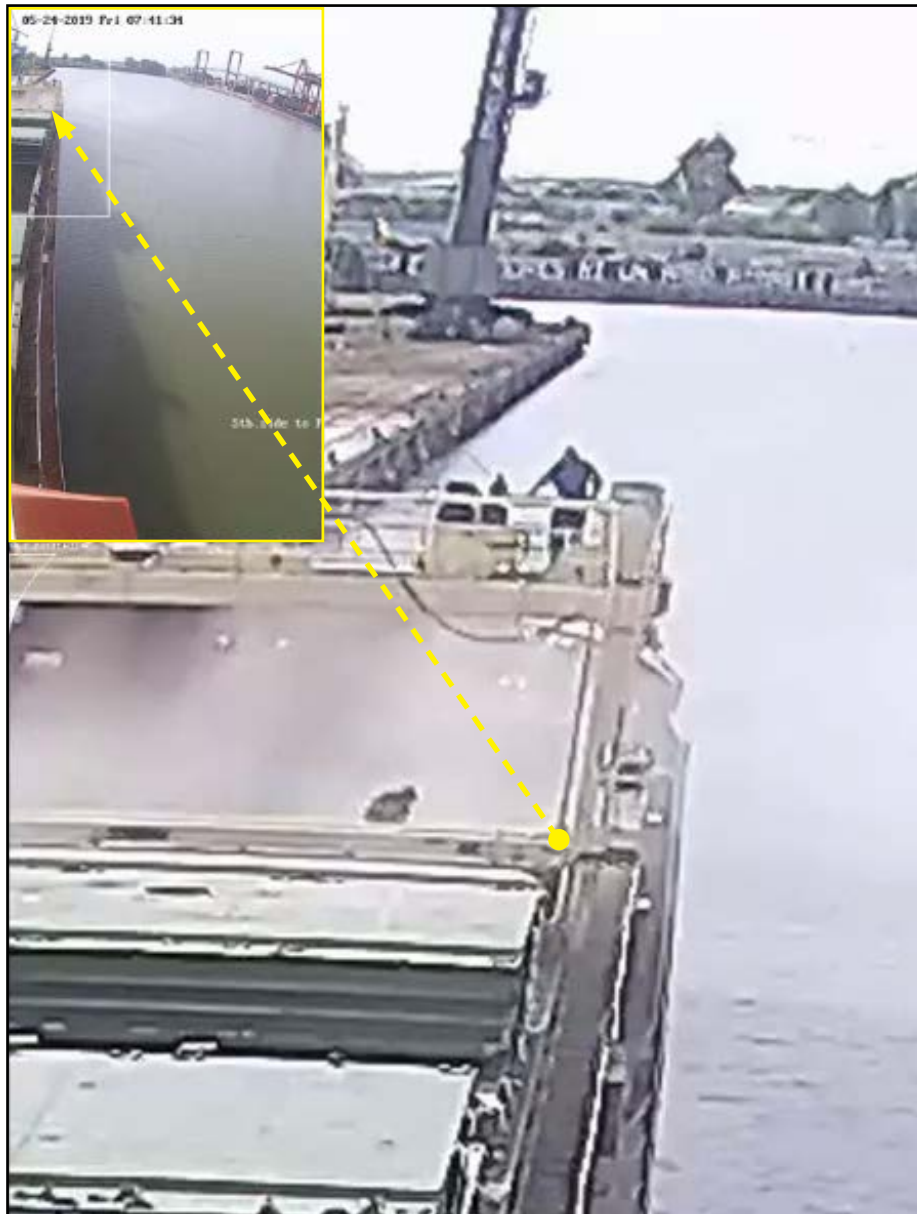
The company's *RA D15 – Loading and Discharging Dusty Cargo (Annex C)* required the use of suitable personal protective equipment (PPE), which included face masks and goggles. During the pre-departure cleaning operation occasional clouds of cement dust were created (**Figure 13**). The deck cadet and two ABs were wearing face masks and eye protection; the 2/O and C/O were not.

Figure 13: CCTV screenshot showing cement dust cloud

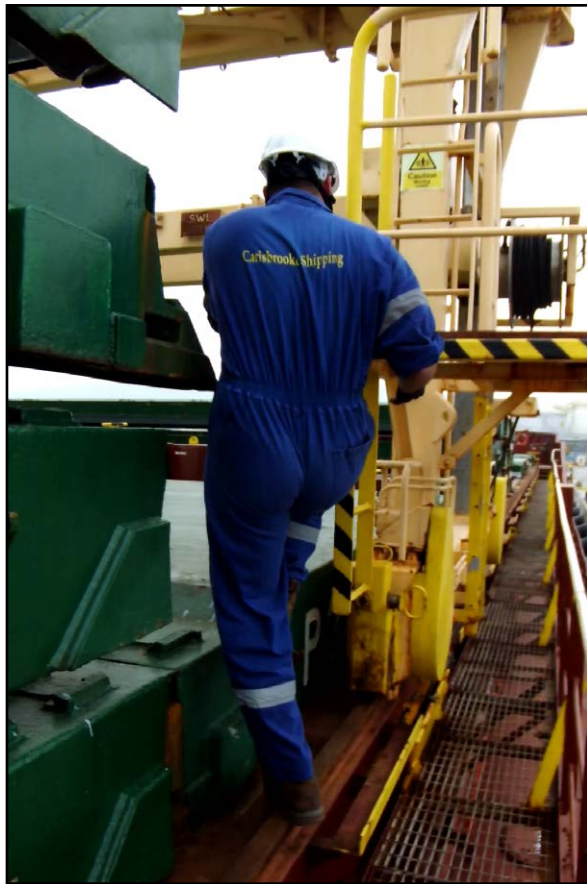
Figure 14: Climbing through the gap between the hatch covers and gantry crane (reconstruction)

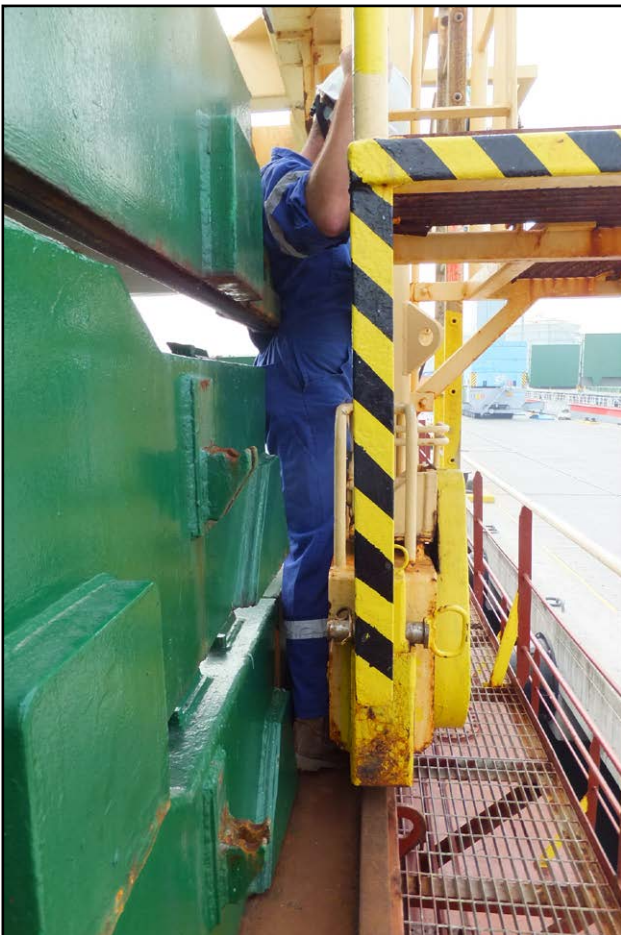
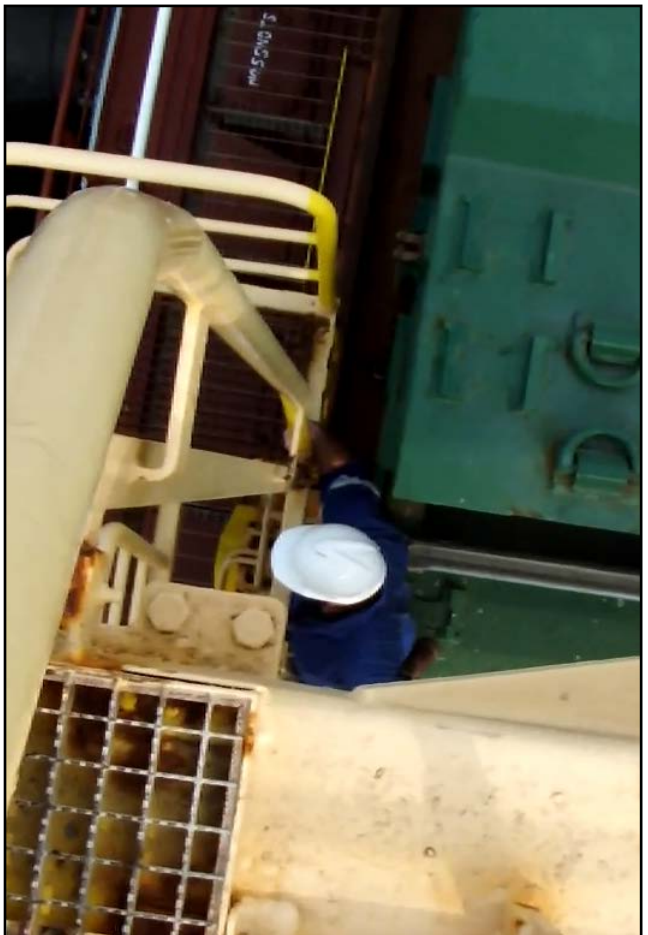
Figure 15: Reconstruction showing size of the gap between the ladder platform and the stacked hatch covers

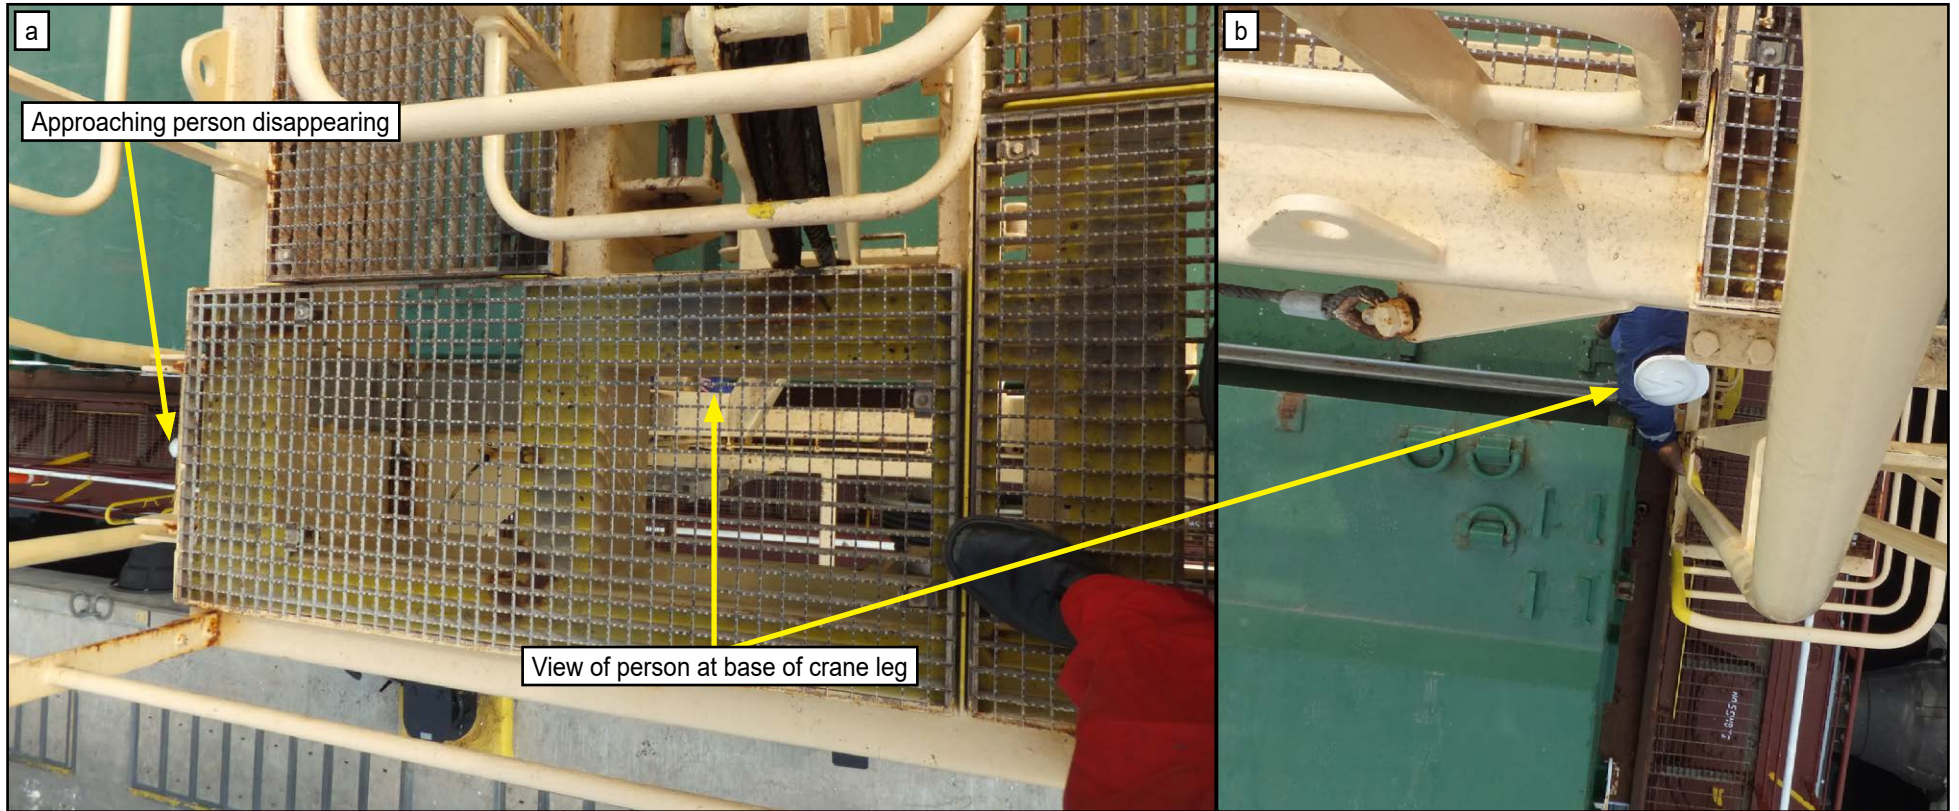
Figure 16: View directly below from the gantry crane operator's position (a) and above ladder (b)

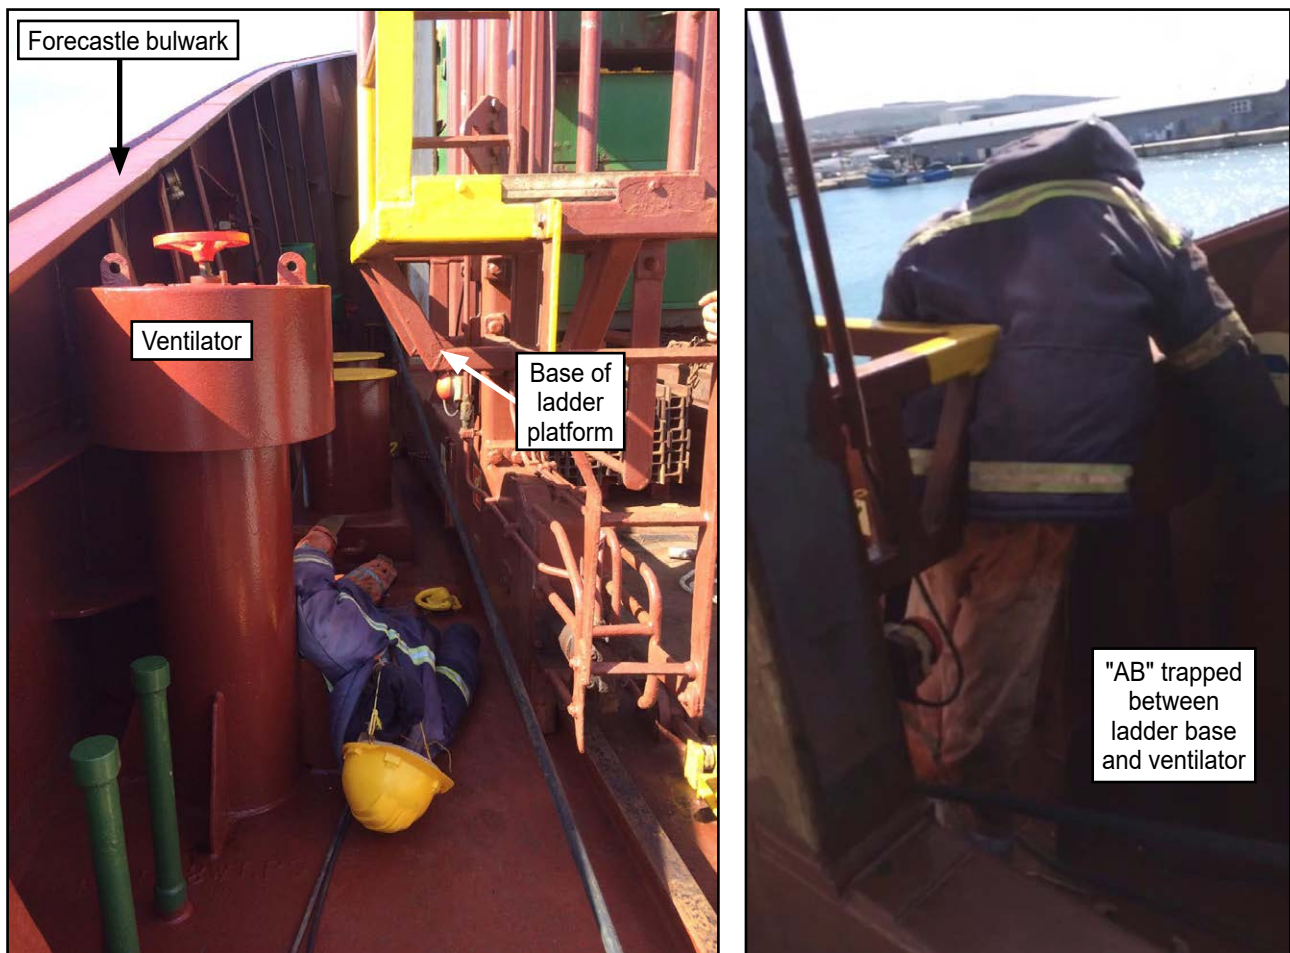
After the accident, a Carisbrooke superintendent, who was on board at the time, carried out a reconstruction and took photographs of the accident site (**Figure 17**). He also sent the CCTV recordings of the accident to Carisbrooke. The master

Figure 17: Reconstruction of gantry crane accident on board *Vectis Progress*
