Report on the investigation of
of the fatal crush accident
on the general cargo vessel

Karina C

at Seville, Spain

on 24 May 2019

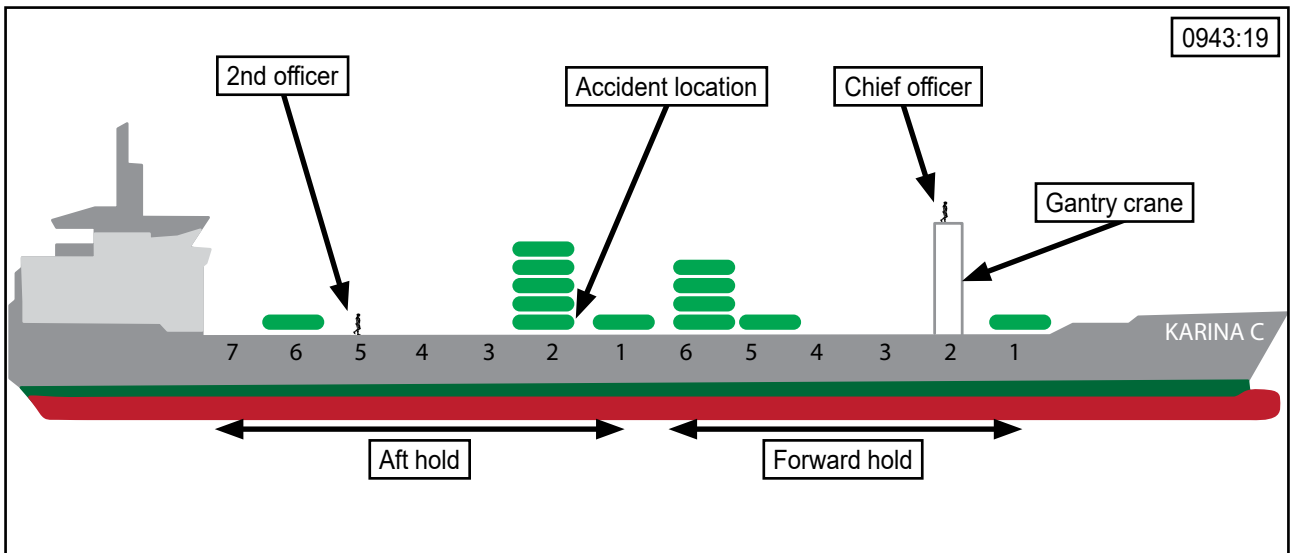
Figure 2: *Karina C*'s cargo hold hatch cover locations immediately before the accident

At 0942, the C/O moved a hatch cover to the forward end of the forward hold and lowered it into position. At 0943:19, he started to drive the gantry crane aft towards the aft hold (**Figure 2**); at the same time, the 2/O finished his sweeping task and started to walk slowly forward along the raised walkway. A couple of seconds later, he stopped, leant against the walkway guardrails, and spoke to the AB working on the aft hold hatch cover (**Figure 3**). At 0943:38, the 2/O resumed his slow walk forward, with the crane still moving towards him.

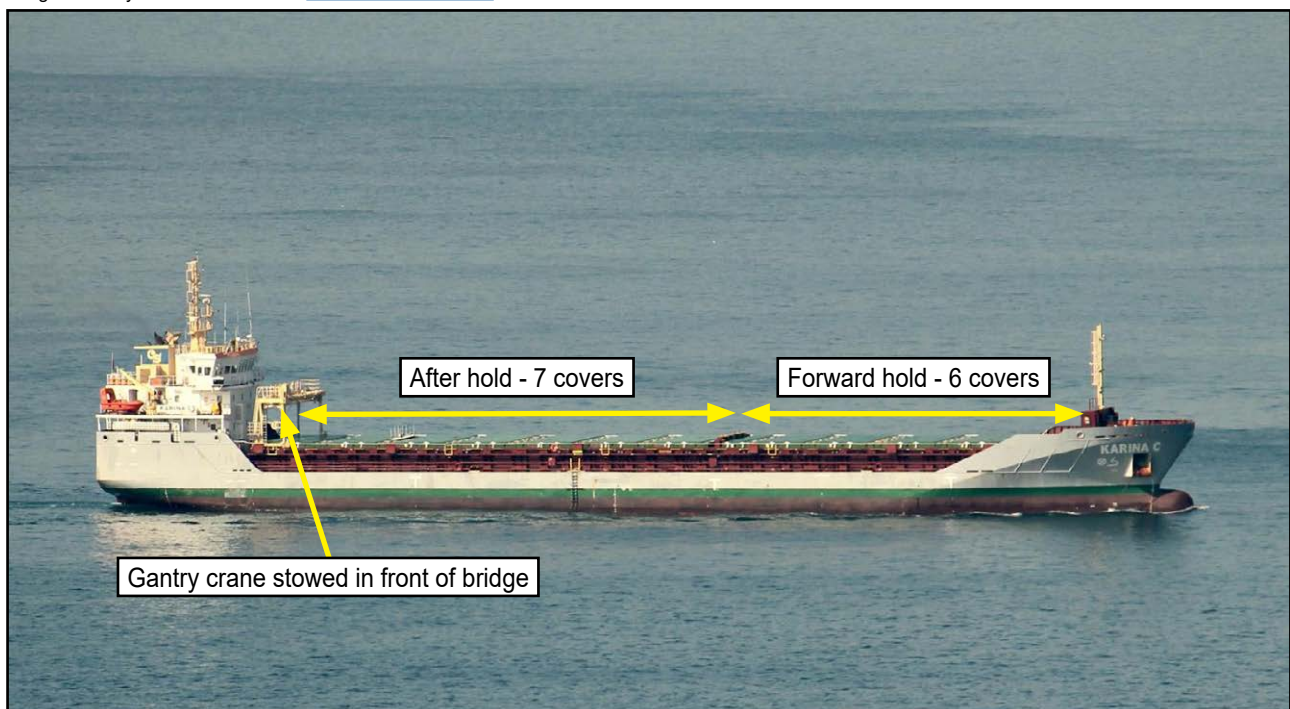
Figure 6: *Karina C*'s cargo hold and hatch cover arrangements

Karina C had two cargo holds; the forward hold had six pontoon-type hatch covers and the aft hold had seven (**Figure 6**). Each hold had a moveable partition bulkhead, which allowed further subdivision to accommodate different cargoes, giving a total of four hold compartments. Hatch covers and partition bulkheads were moved with the gantry crane. The hatch covers were not interchangeable and had to be placed onto the hatch coaming in sequence (**Figure 7**) before cleats were used to secure them. The coamings were provided with water drain channels.

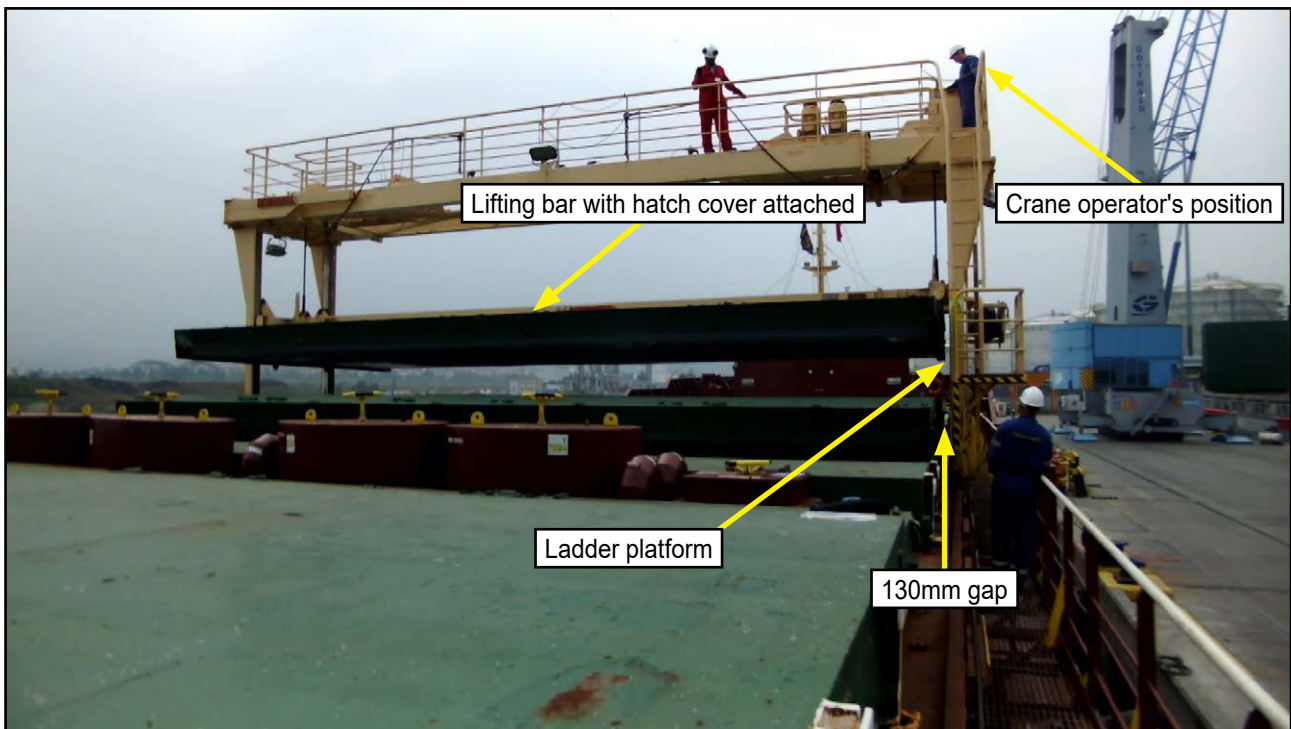
Figure 9: Gantry crane looking from aft

The operating position was located at the top of the crane on the starboard side. Access to the crane control platform was by one of two short vertical ladders (one from the starboard walkway, the other from the top of the hatch covers) to an intermediate platform, and then an inclined ladder to the top. The vertical distance between the raised walkway and the crane operator's platform was 4.75m (**Figure 9**).

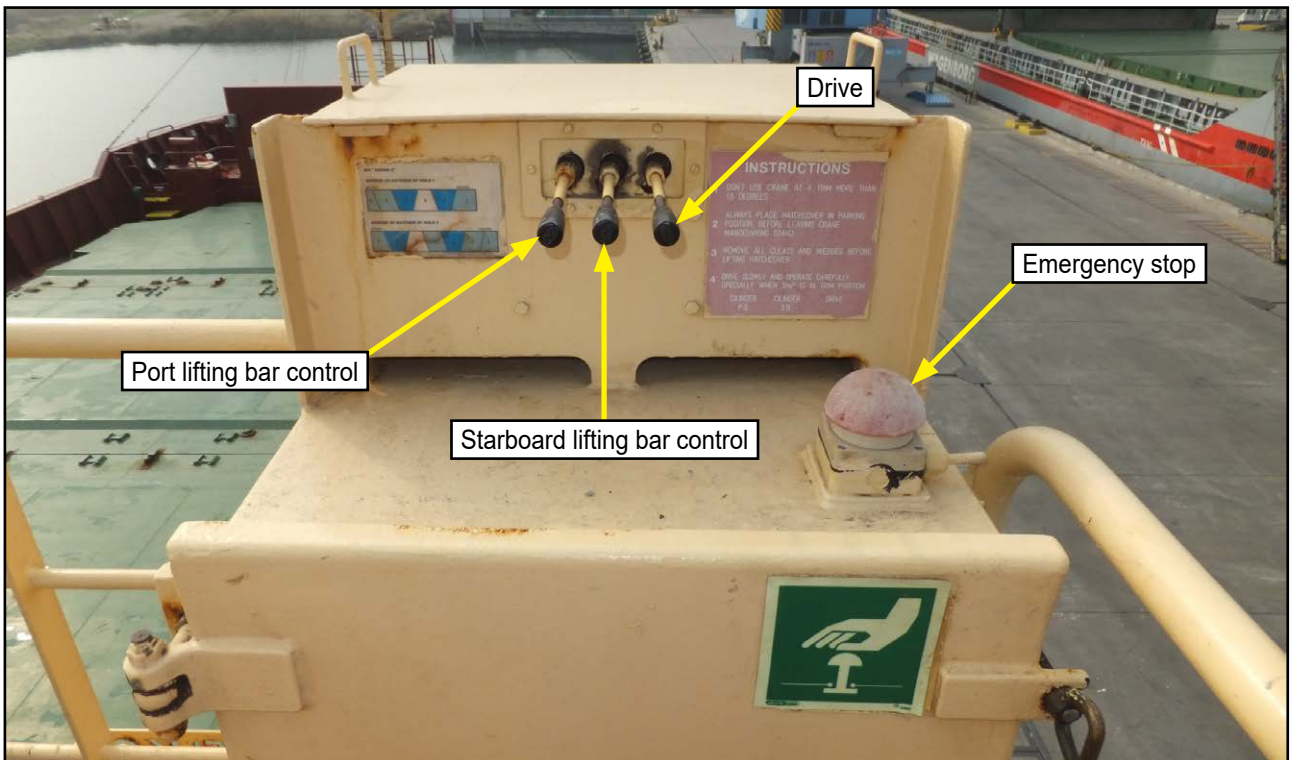
Figure 10: Gantry crane control panel

The crane had three control levers: two for operating the lifting bar through hydraulically-operated cylinders and wires, and one for driving the crane forward or aft (**Figure 10**). The drive lever had three positions: forward, stop and reverse. The crane speed was variable depending on the position of the drive lever; at the extreme end position of the lever, the crane reached a speed of 20m/minute. Bringing the drive lever to stop applied brakes on the two forward wheels.

The crane had three emergency stops; two at walkway level on the outboard sides of the port and starboard aft crane legs (**Figure 11**) and one at the driving position (**Figure 10**). To operate the port or starboard emergency stops, a crew member needed to be stationed on the outboard side of the crane between the crane and the walkway guardrail. The gap between the crane and the guardrail was about 350mm wide (**Figure 12**).
